INVESTIGATION OF COMPOSITE COATING  
SYSTEMS FOR RAIN-EROSION PROTECTION

Florida Atlantic University

Naval Air Systems Command

15 July 1974

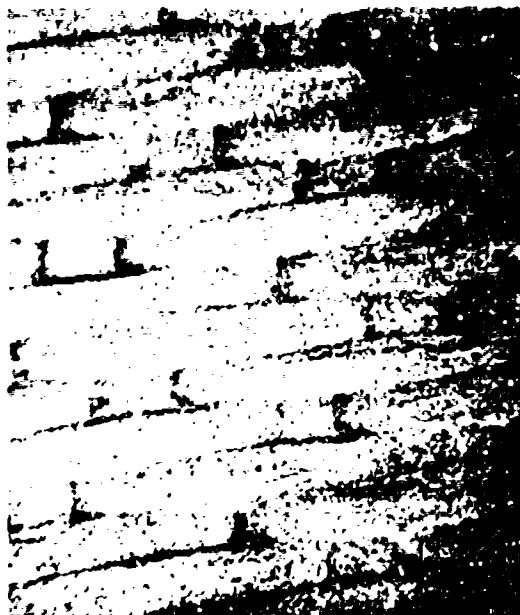
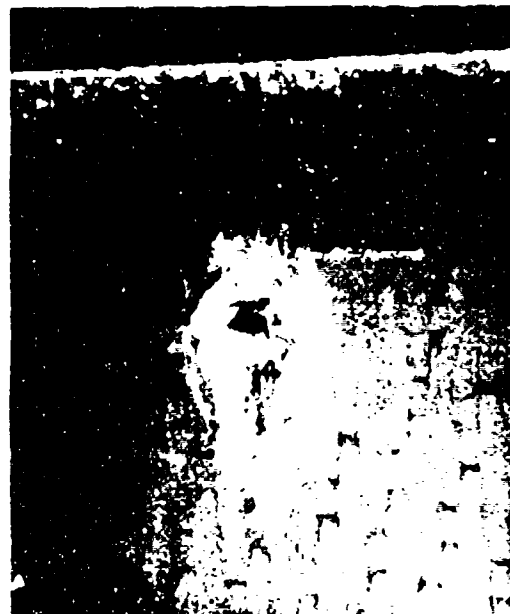
Single-Layer  $S_2$ , Spec. No. 4  
Adhesion Condition at Specimen  
Center after 40 minutes Test, 15X

Single-Layer  $S_2$ , Spec. No. 4  
Hole and Evidence of Incipi-  
ent Frame Crack, 7.5X

Two-Layer  $H_1S_2$ , Spec. No. 1  
Adhesion Condition at Specimen  
Center after 45 Minutes Test, 15X

Two-Layer  $H_1S_2$ , Spec. No. 4  
Hole and Crack Along Frame  
after 44 Minutes Test, 7.5X

FIGURE 2. MAGNIFIED VIEWS OF DAMAGE ON SINGLE-LAYER COATING  
AND TWO-LAYER COMPOSITE COATING

Because the specimens were flat, the irrelevant stress of unequal yield<sup>2</sup> was eliminated. However, there is some evidence that the restraining frame that holds the flat specimens to the rotor may provide a machine effect that could play a role in the failure of specimens. Specimen No. 4 may have a frame induced crack near the hole through the coating (see upper right picture of Figure 2). This crack runs parallel to the edge of the specimen at a distance from the edge that corresponds roughly with the width of the restraining frame. There is, however, no evidence

The specimens of single-layer  $S_2$  coating tested in 1974 differ from specimens of single-layer  $S_2$  coating tested in 1973 in that no evidence of isolated cracks or of adhesion-loss runners was reported<sup>2</sup> in 1973. Adhesion loss that developed on  $S_2$  single-layer coatings in 1973 was associated with protruding wool fibers and resembled the adhesion loss that developed on the  $H_1S_2$  two-layer coating in 1974 (see lower left picture of Figure 2).

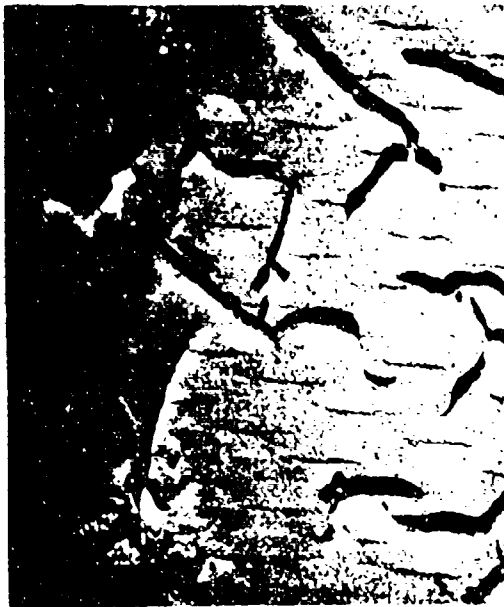
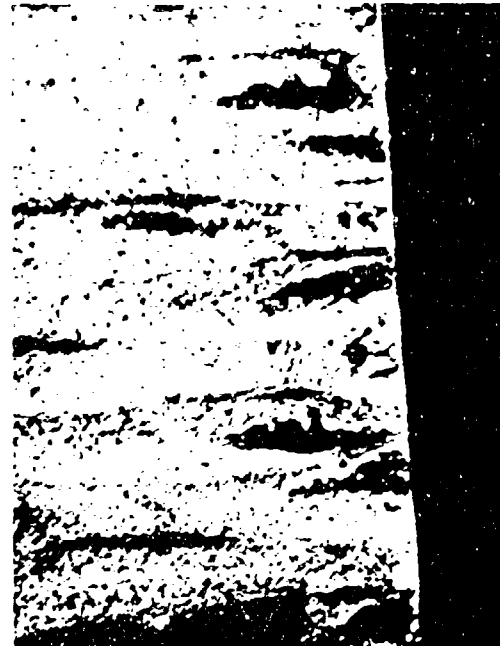
Multilayer Coating Spec. No. 1  
All-Over Pattern of Cracks 7.5X

Multilayer Coating Spec. No. 3  
Crack that Accumulated Adhe-  
sion Loss and Formed Hole 7.5X

Stress-Bumper Spec. No. 1 & 2  
Adhesion Loss Accumulating  
Along Glass Fibers 15X

Stress-Bumper Specimen Prior  
to Test Showing Adhesion-Loss  
Runners along Saw Cut 22.5X

FIGURE 3. MAGNIFIED VIEWS OF DAMAGE ON MULTILAYER COATING  
AND STRESS-BUMPER COATING

Specimen No. 1 of the multilayer composite coating exhibited quite unusual behavior in that cracks formed all over its surface. A section of the all-over crack pattern is shown in the upper left picture of Figure 3. The cracks ranged in complexity from simple isolated straight and curved cracks to cracks with many branches. There are two large holes (see Figure 1) on this specimen and seven additional small holes associated with the cracks. There is one instance in which a hole has formed on a single isolated straight crack. It is possible that a branch crack that may have existed could have been eliminated at the time the hole formed. There is no evidence on this specimen of a

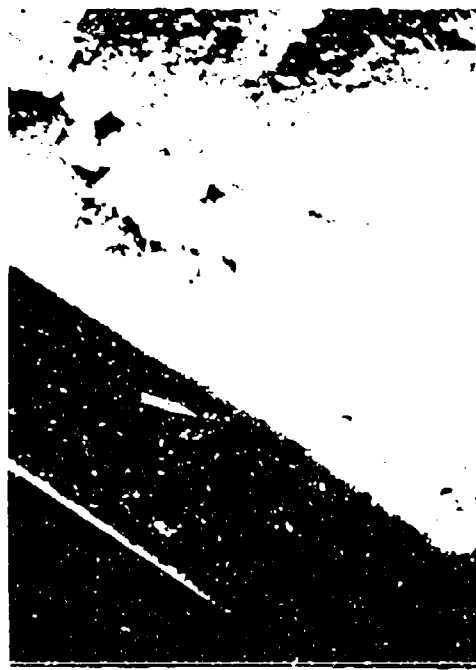
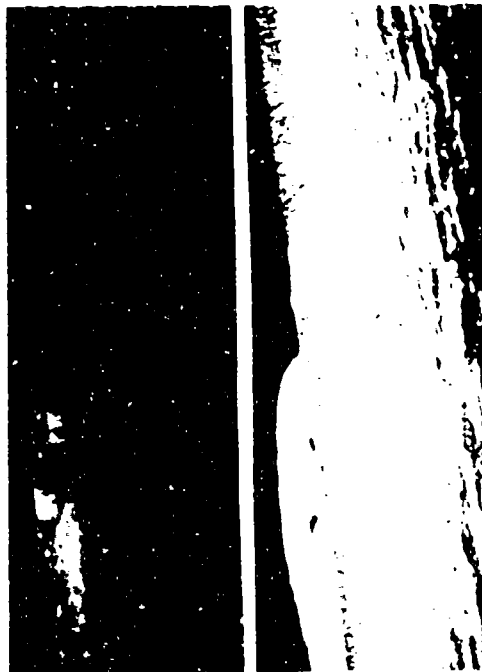
Network of Cracks on  $H_1S_2$  Specimen No. 1

Crack Along Frame on  $S_2$  Specimen No. 4

Network of Cracks on  $S_2$  Specimen No. 4

Evidence That Coating Is Not Worn Thin

FIGURE 6. VIEWS ON POLYURETHANE COATINGS TESTED FOR SAND-EROSION RESISTANCE

The upper right picture of Figure 6 shows the crack that developed along the restraining frame at the low-speed end of Specimen No. 4 of  $S_2$  coating. The  $H_1S_2$  specimens that were tested under sand impact at the same velocity showed no evidence of a crack along the restraining frame.

The lower right views of Figure 6 were taken on Specimen No. 4 of  $S_2$  coating. They provide evidence that the coating was not worn thin by the sand but that it broke away between intersecting cracks. In the lower of these two pictures the camera is focused on the edge of the specimen which was protected from sand impacts; this view shows the original thickness of the polyurethane coating. A white structure (out of focus) is visible above the coating surface. This is a raised section of

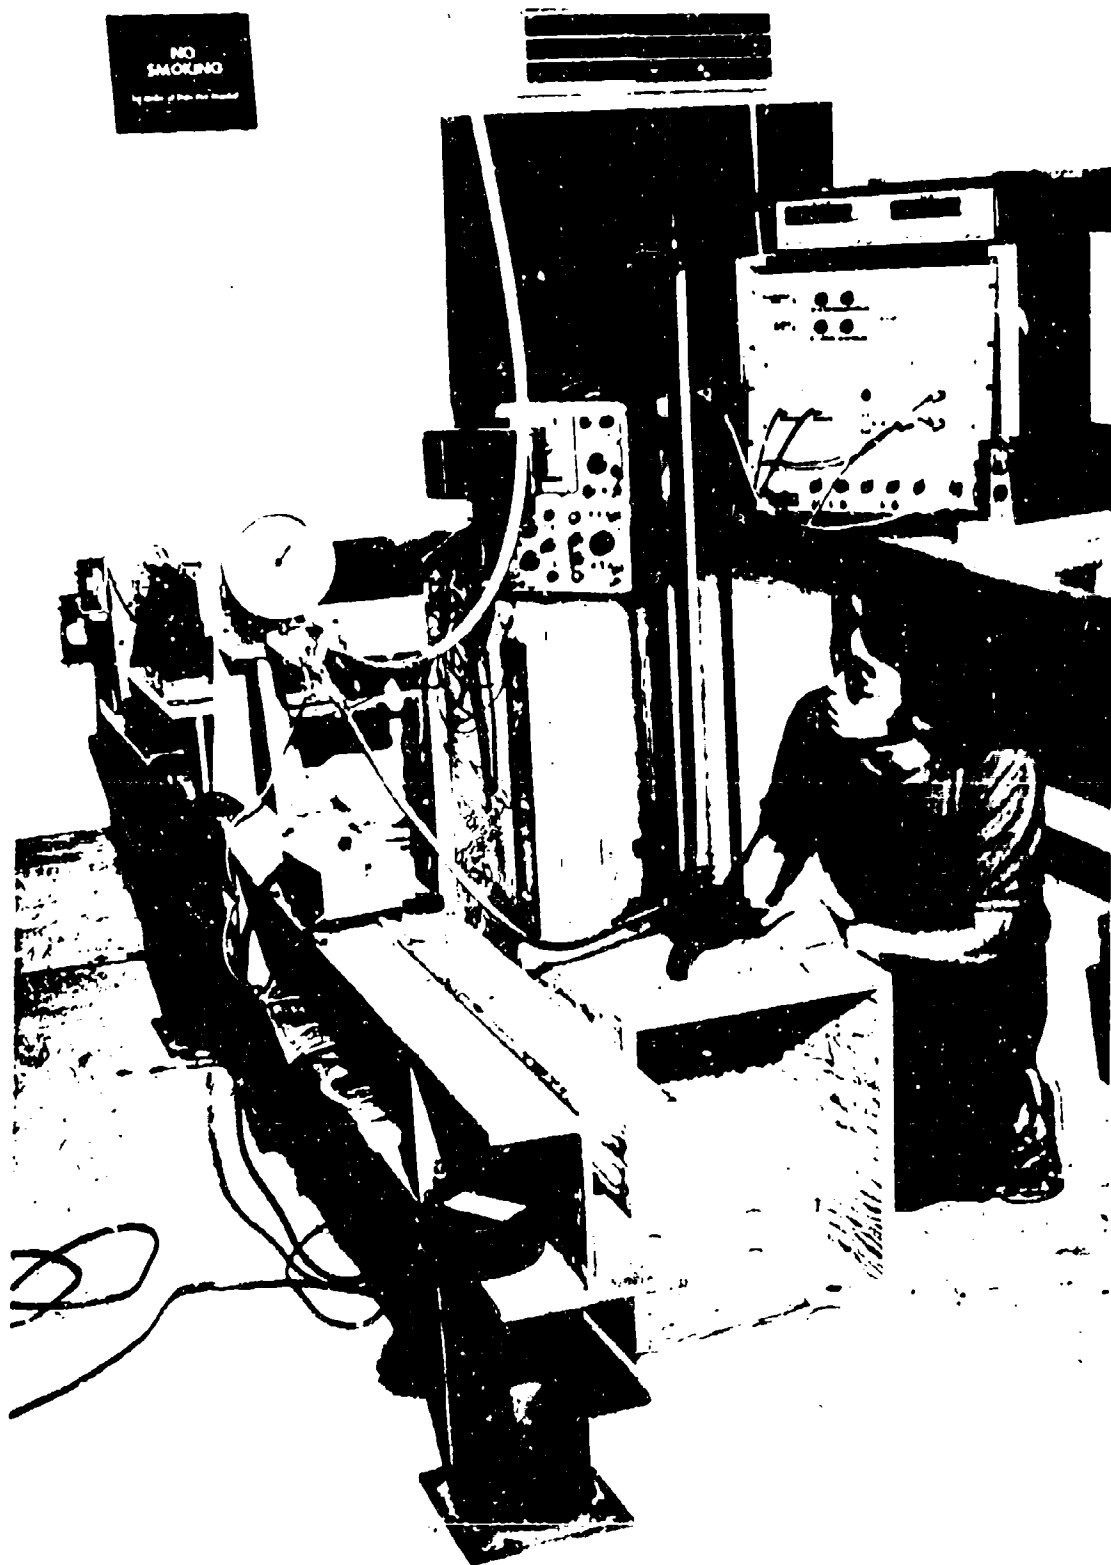
FIGURE 10. SMALL GAS GUN IN FULLY RESTORED OPERATING CONDITION

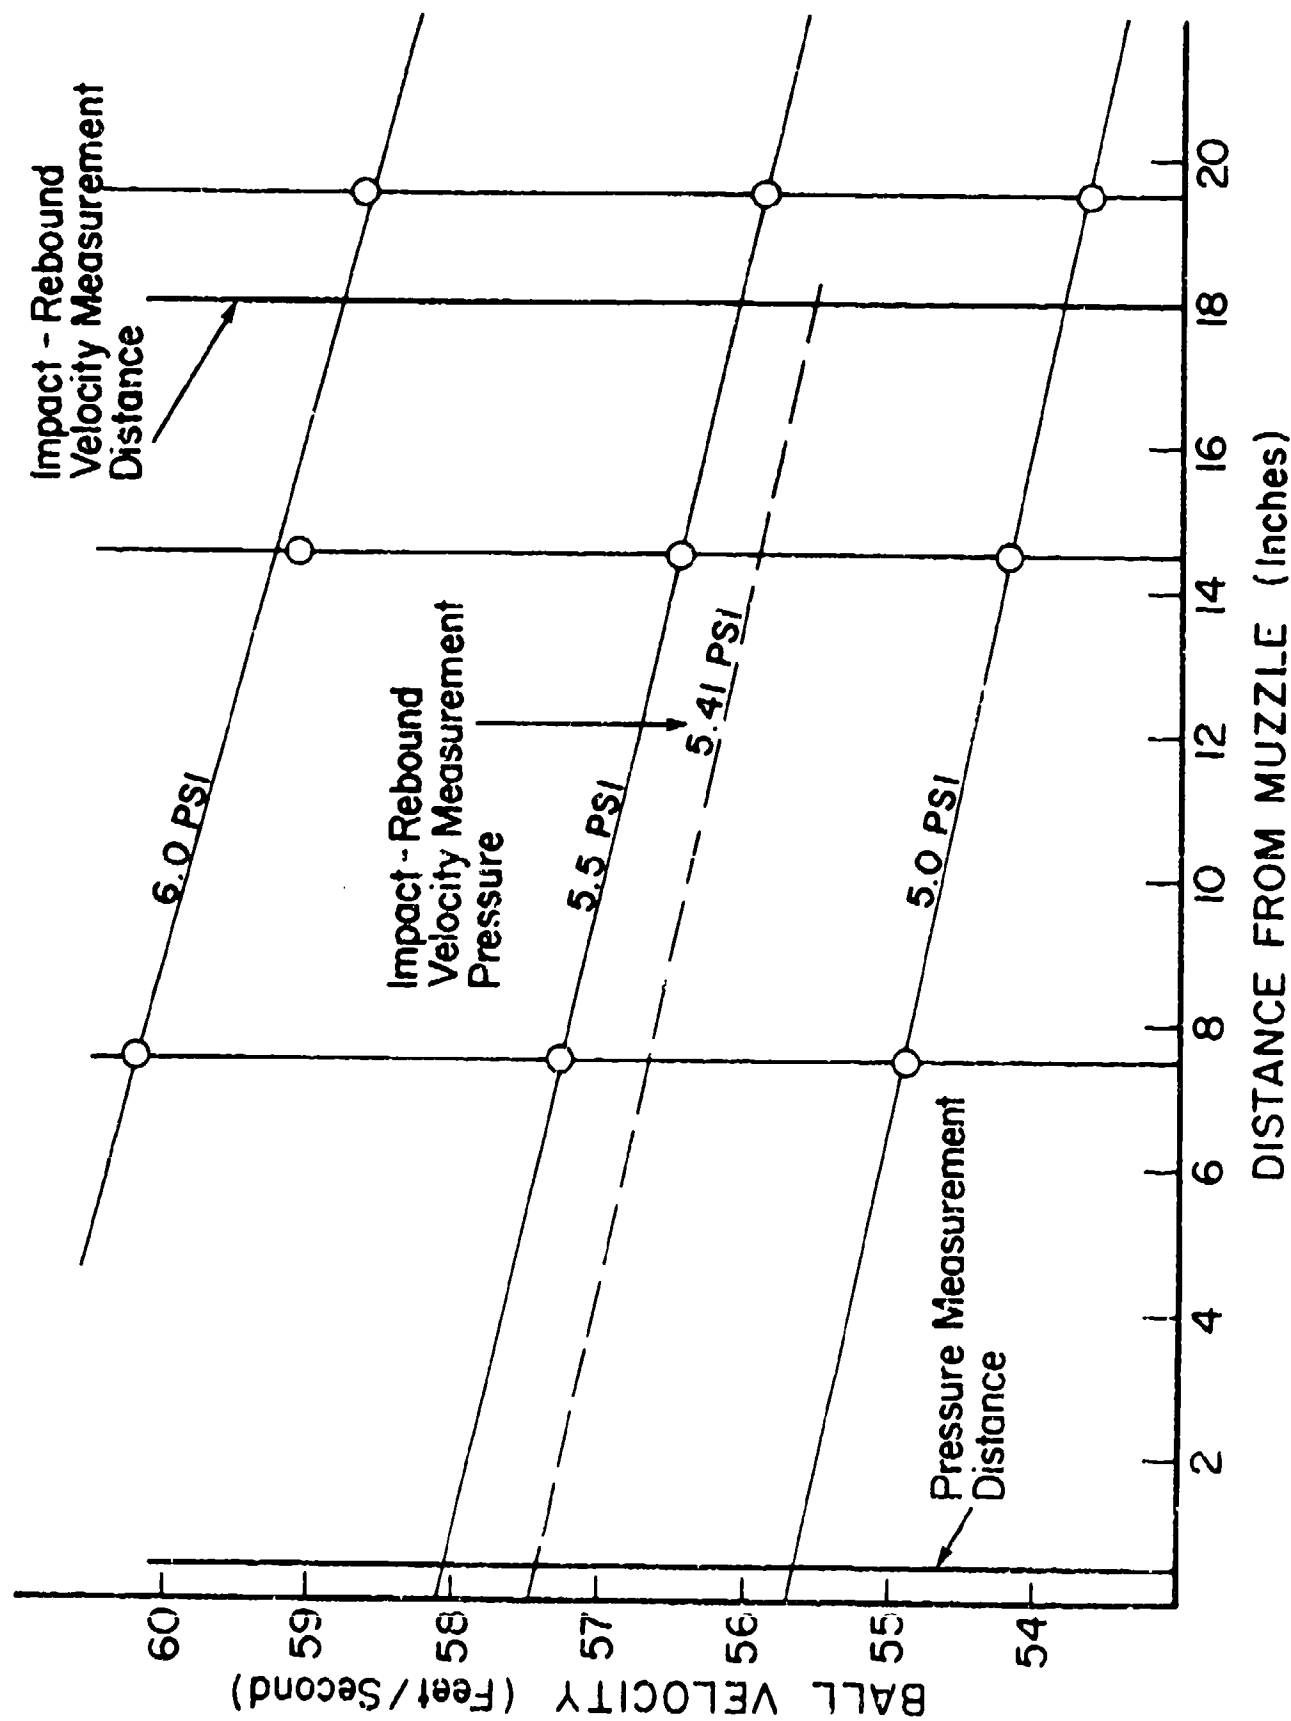
FIGURE 11. PLOT OF MEASURED VELOCITY AGAINST DISTANCE FROM GUN MUZZLE TO MIDPOINT BETWEEN LIGHT-LADDER SCREENS

"standard velocity" at the position of the coating specimen and the loss in velocity due to air drag was followed. The velocity produced at three different distances from the end of the gun barrel to the midpoint of the 12-inch separation between the light-ladder screens was determined for three arbitrary compressed air pressures, namely, 5.0, 5.5, and 6.0 psi. Each velocity identified with one of the specified distances was the average of five good firings. The velocities are plotted against distance in Figure 11. Interpolation between lines for the compressed air pressures that were used makes it possible to select the air pressure needed to produce a given "standard velocity" of impact against a coating specimen placed at any specified distance from the gun muzzle. The slopes of the lines in Figure 11 that were obtained at compressed air pressures of 5.0, 5.5, and 6.0 psi are 1.27, 1.33, and 1.55 ft/sec/ft, respectively. The slopes of the lines give the average loss in velocity due to air drag over the velocity ranges represented.

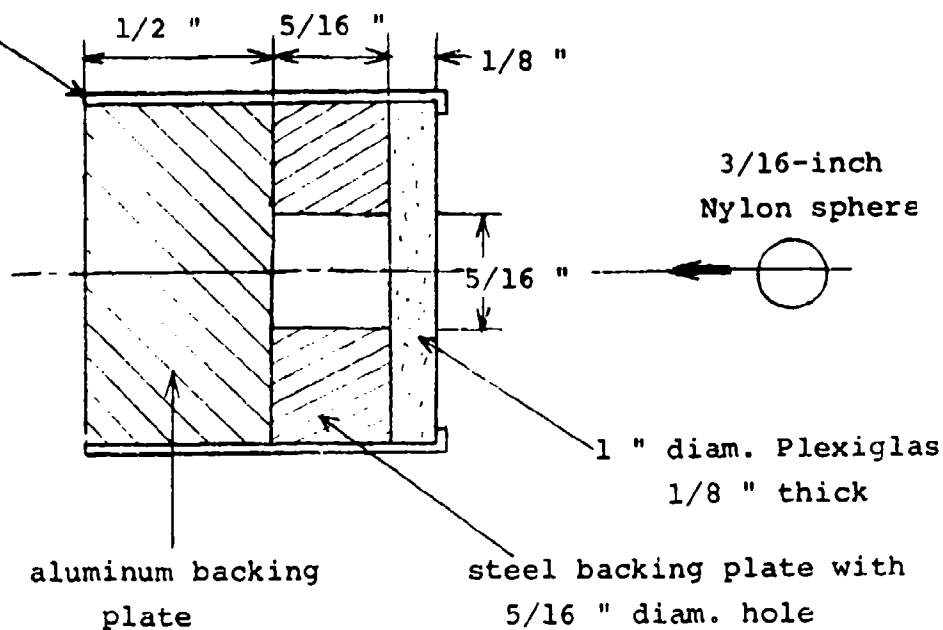
A. GEOMETRY USED TO PRODUCE FLEXURE IN PLEXIGLAS SHEET

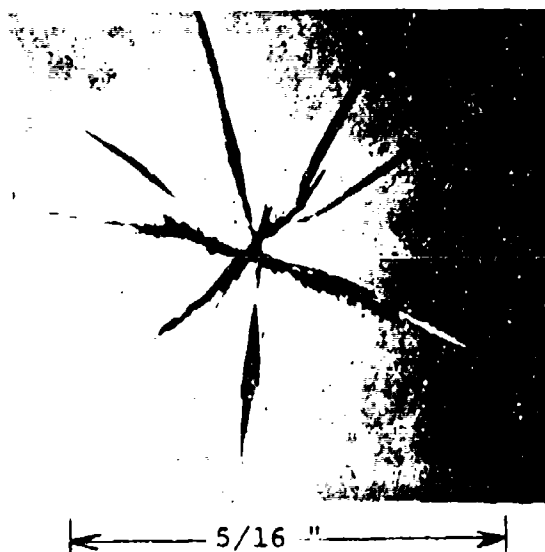
B. MAGNIFIED VIEW OF STAR CRACK FORMED

FIGURE 15. CRACK PRODUCTION UNDER FLEXURE PRODUCED BY NYLON-SPHERE IMPACT
